Masonry Walls Analysis from Shish Mahal Lahore–Pakistan

MASONRY WALLS ANALYSIS FROM SHISH MAHAL IN LAHORE-PAKISTAN

Lahore Fort is situated in the north-west corner of the Walled City of Lahore. Shish Mahal within the Lahore Fort was built in 1631-1632 by the then Mughal Emperor Shah Jahan. The restoration works were done recently for the ceiling of Shish Mahal including the fixing of the roof, glass work and re-plaster. The side rooms and main courtyard were also restored. Nothing, however was properly proposed and implemented for masonry walls of Shish Mahal on which it is standing. Patches of bricks and plaster have deteriorated from walls due to effect of weather conditions.

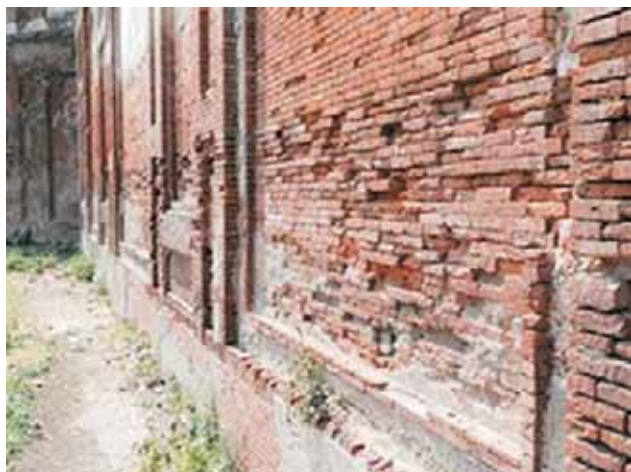
Figure-4: Erosion of mortar from brick wall.

The function of mortar is to bind the bricks; it provides adhesion between the bricks. Mortar has eroded from the masonry walls of Shish Mahal (Figure 4).

The bricks have also been deteriorated due to erosion of mortar. The reason for this erosion is water penetration leading to the concentration of moisture, dampness, plants growing on the walls and presence of salt crystallization.

If proper materials are used for mortar and lime plaster with skilled hands, then erosion could be avoided.

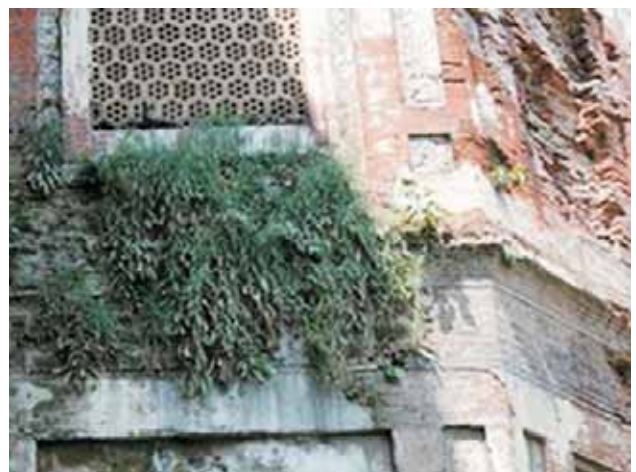
Figure-5: Fungal stain and plantation.

Fungus has occurred due to presence of water or high moisture content in masonry walls. Plantation is seen on masonry walls of Shish Mahal (Figure 5). Fungus flourishes in damp environmental conditions having high humidity and lack of ventilation (Lourenco, et. al., 2006). Fungus also flourishes in water disposal areas of walls of Shish Mahal. The plantation is also due to seeds present in the fecal dropping of birds, specially pigeons. The mortar joints and holes in walls provide shelter and a suitable ground for any seeds to grow. The roots go deep into the walls causing deterioration, cracks and water penetration.

The fungus problem can easily be controlled if moisture and dampness is controlled. There should be no room in the walls for growth of seed which comes through birds. The walls should be examined time to time for growth of any vegetation.
